STRATEGIES FOR
ENERGY
EFFICIENT
REMODELING
**SEER
2003
CASE
STUDY
REPORT**

STRATEGIES FOR ENERGY EFFICIENT REMODELING

SEER 2003

CASE STUDY REPORT _____

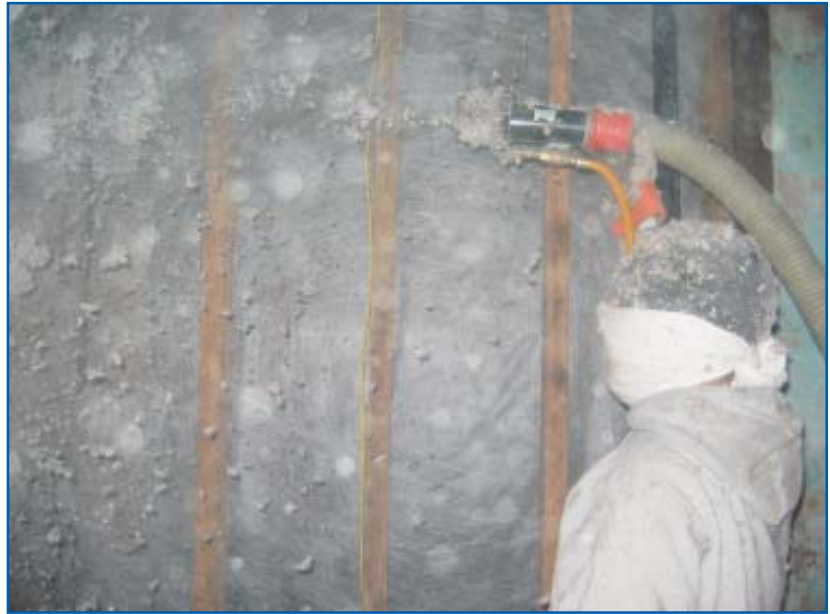
Blown cellulose insulation

The two most common options for insulating existing wall cavities with coverings on both the exterior and interior of the framing are spray foam and blown fibrous insulations such as fiberglass and mineral wool or blown loose-fill insulation such as cellulose⁵. **Blown cellulose** was selected for this case study based on:

The estimated installation costs⁷ for blown cellulose insulation is approximately \$0.43/sf with an additional \$1.74/sf to drill holes for blowing access. The total installed costs then for installed blown cellulose insulation is about \$2.17/sf of insulated wall area. Further, the estimated installed cost of the wall insulation of the case study house

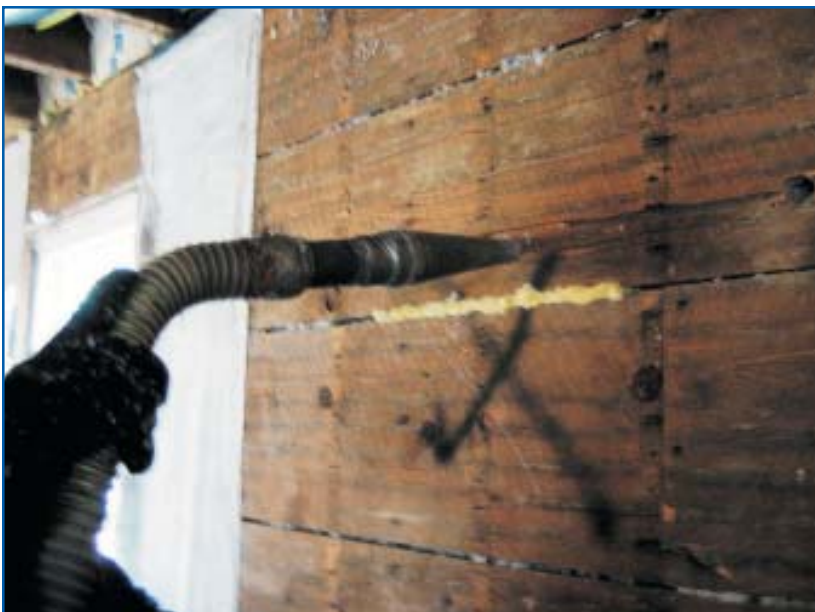
Insulation blown into wall cavities

Based on the existing wall conditions, two wall cavity insulation choices became clear – the use of blown insulation materials such as fiberglass, cellulose and rockwool, or use of a foam-in-place insulation. Blown or foamed insulation materials provide more of an opportunity to completely fill irregular wall cavities and may be installed through small openings in the framing bay. The blown or foamed insulation products are particularly adaptable to insulating wall sections that have coverings on both the exterior and interior of the framing members.

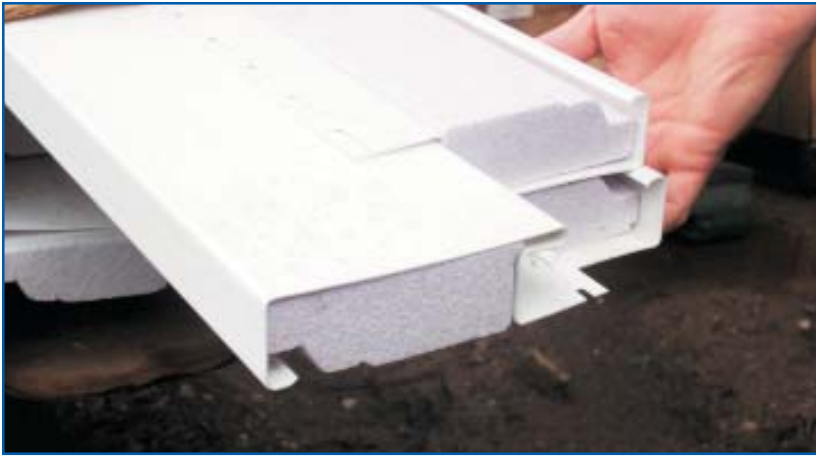
Insulated siding trim

Based on the cost estimates and primarily the labor savings with a larger coverage area, there is virtually no difference between the installed costs of each system. The cost of installing the board insulation to provide a thermal break for the framing adds approximately \$970 but with the selection of the insulated vinyl siding, the additional cost is about \$900.

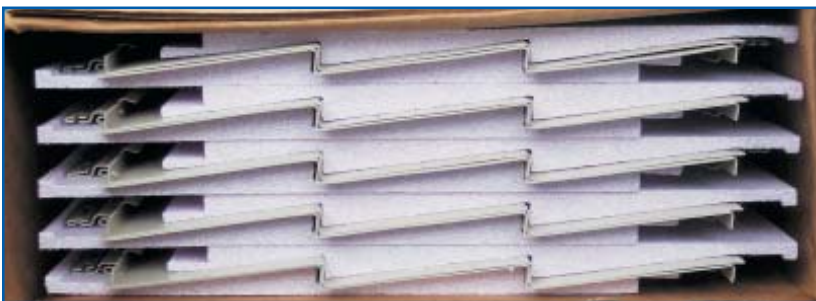
Insulated siding

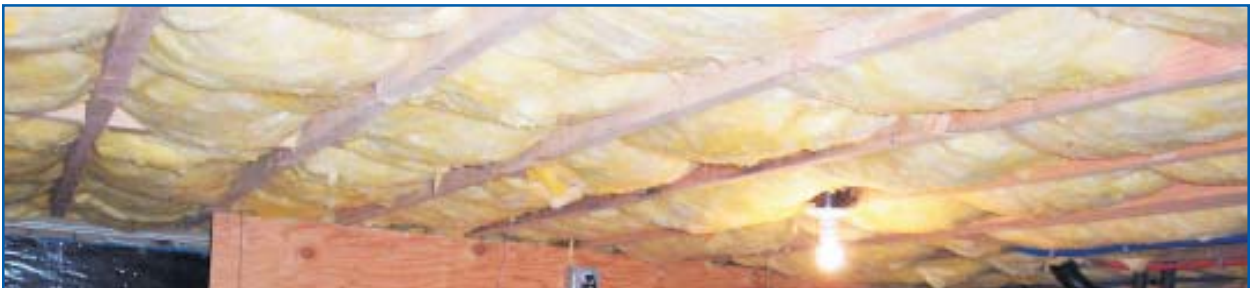
Floor insulation between joists

For the case study home, where the basement is potentially subject to regular damp conditions, the floor was chosen for insulation rather than the basement walls. The floor insulation options include blown or foamed insulation and batt insulation. In this location, use of batt insulation is preferable due to the higher cost of installing blown or foamed insulation products. The typical insulation level required for this location would be at least R-19. Use of R-30 is preferable if the floor joists are nominal 2x10's as is the case with the case study house. The additional cost of upgrading the floor insulation from the minimum R-19 to R-30 is approximately \$328.

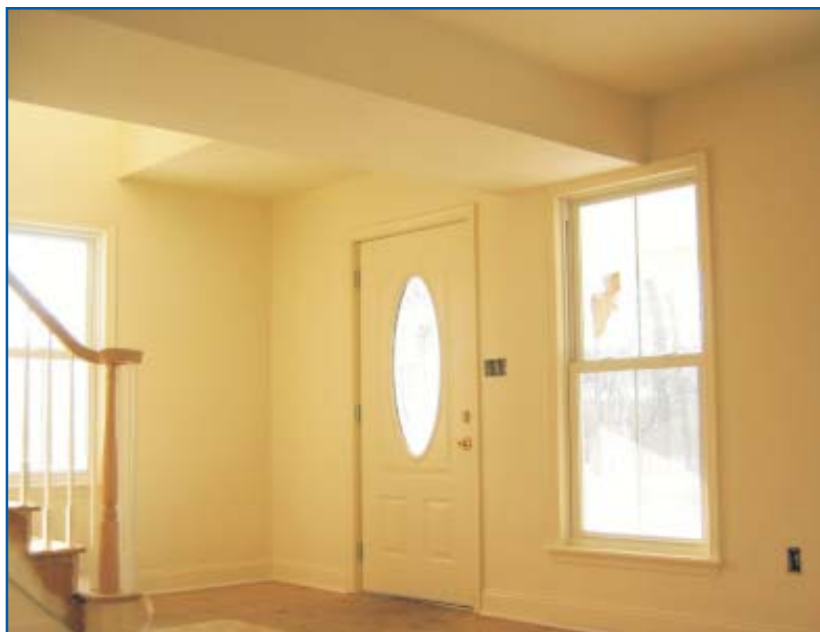
Energy efficiency windows and door in cottage

The additional cost of selecting energy efficiency features for the windows varies significantly between manufacturers. Generally, the added cost of low-E coatings and gas fill ranges from a low of a few dollars per window to nearly \$100. But many manufacturers offer an energy efficient option that includes low-E coatings or a combination of low-E coatings and gas fill, for their windows at a cost of about \$2/sf of window area. For the case study house with 196 sf of windows then, the additional cost for energy efficient windows is about \$400.

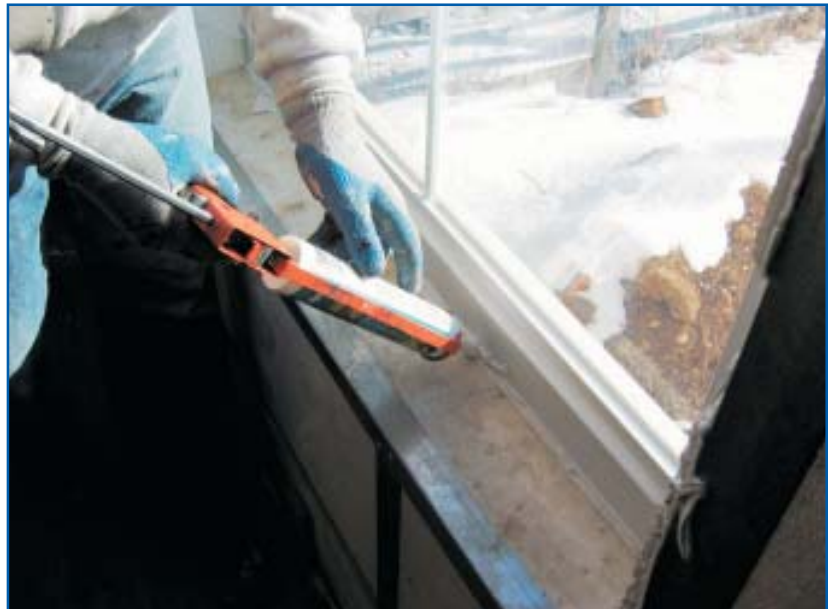
Air sealing around windows

- ✓ Exterior plywood sheathing was glued to framing
- ✓ Window frames were caulked to the framing
- ✓ Wallboard was glued to framing
- ✓ Sill seam and band joist areas were foamed
- ✓ Floor and wall penetrations (inc. at stairway) were foamed

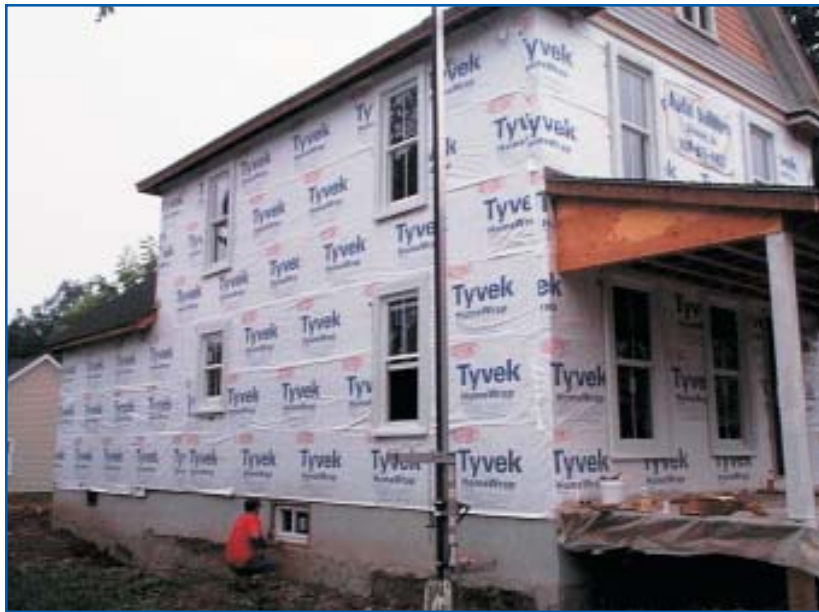
Air barrier on outside of house

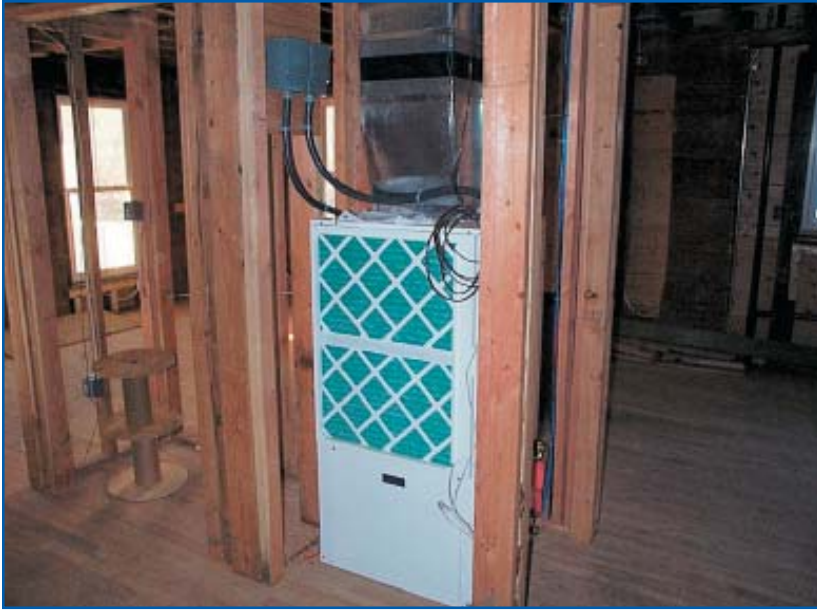
Ground source heat pump in conditioned space

Since the site had a high water table, a ground source heat pump was investigated. After some consultations with several manufacturers, installation contractors, and energy modeling, this system was chosen for its low annual operational costs. The large lot enabled a cost effective horizontal closed loop configuration which was trenched and installed by remodeler (with HVAC contractor) and serves a total of three packaged units for the two homes on the site. The two-ton compressor and air handler unit in the study home, as well as all supply and return ducts are located within conditioned space which dramatically reduces system losses throughout the year. In addition to this, all ductwork was rigid metal and

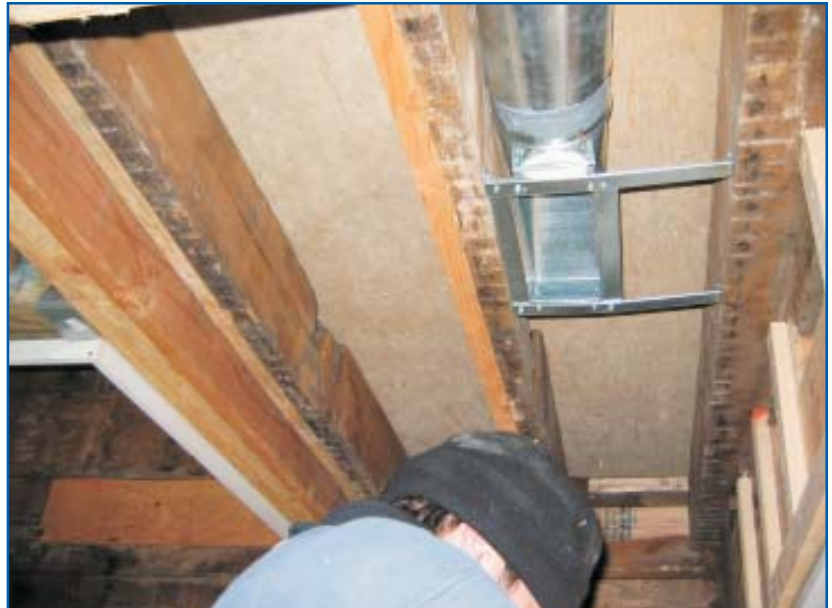
All duct joints sealed

mastic was installed on all duct connections. These improvements to efficiency of the distribution system allowed the unit to be downsized by one-half a ton.

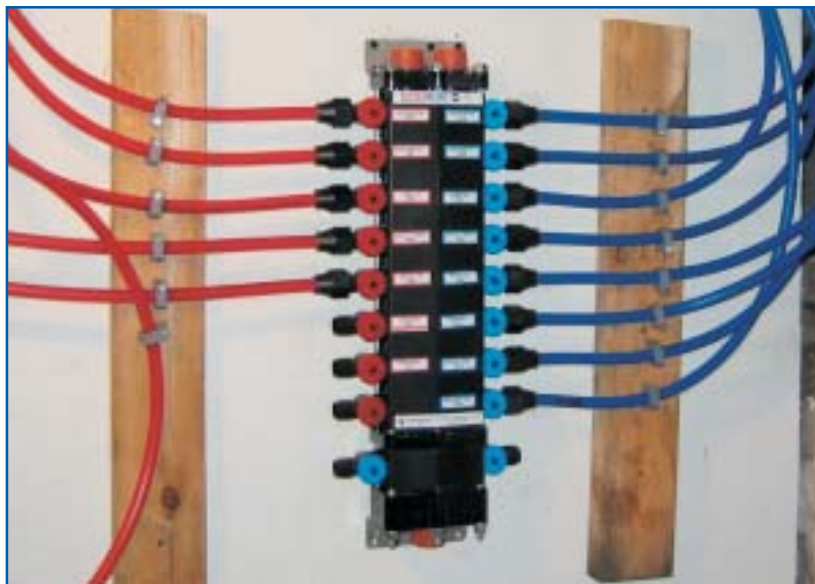
Manifold plumbing system

As with other systems in the home, the water distribution and heating systems required replacement. An estimate of \$2,700 was obtained for the supply and installation of copper supply lines for the hot and cold water in the home. In comparison, a price of \$2,200 was secured to supply and install a single central manifold and PEX piping for all the supply lines in the home. This savings was primarily due to the reduced labor costs associated with running the flexible supply lines since the materials costs were very similar.

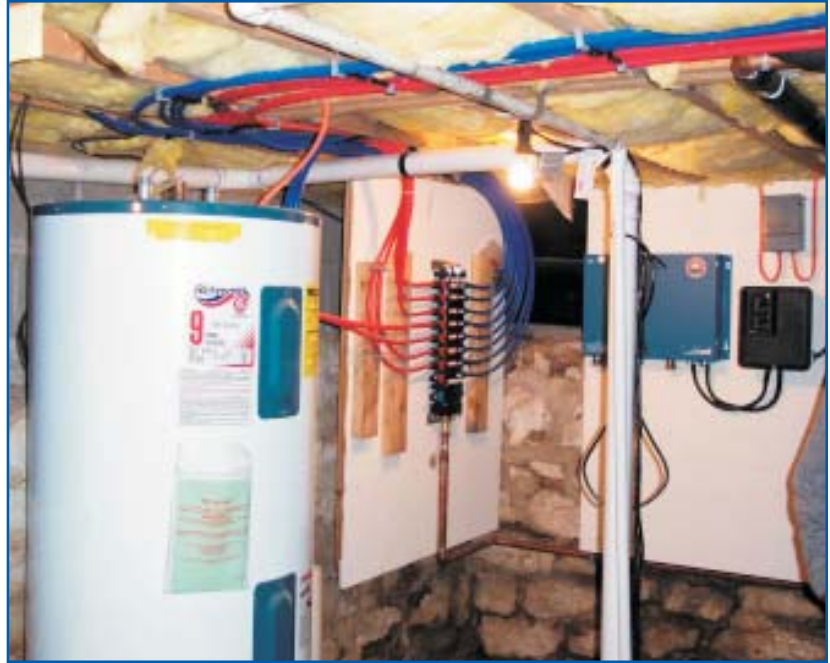
Hot water system in cottage

The original design for the water heating system was to include a “typical” propane-fired storage tank with an energy factor of approximately 0.56 located in the basement. While this would have been a relatively inexpensive option to purchase and install, the performance of this equipment, and expected standby losses due to its location in unconditioned space, would have cost significantly more to operate over its lifetime. The choice of

a solar preheated tank and tankless demand heater limited the storage tank losses to energy generated only by the solar system. The solar contribution is expected to represent approximately 57% of the annual hot water load. The estimate for the cost of

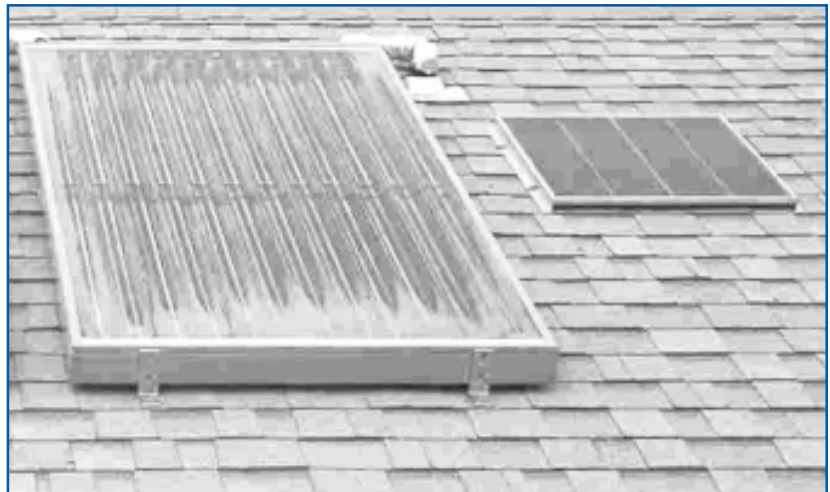
Solar thermal collector with PV panel for pump

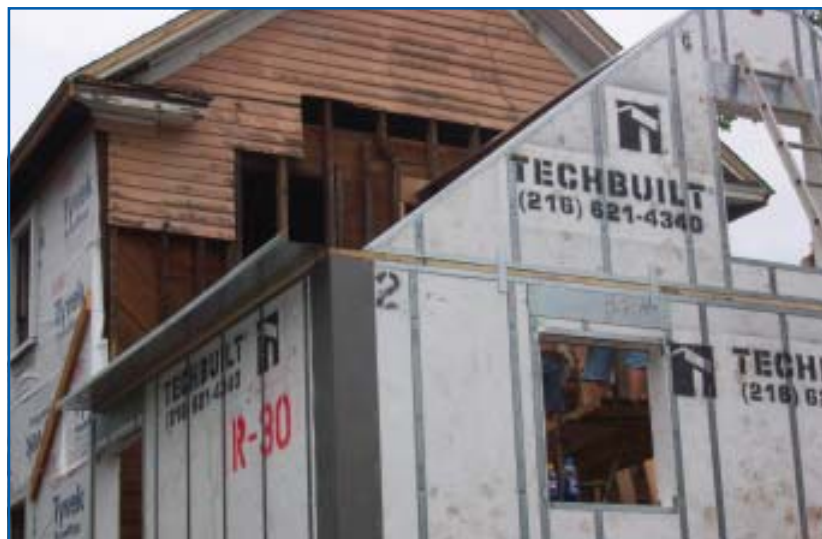
Addition construction using foam panels

The addition is made from pre-manufactured structural EPS foam and steel tube panels and therefore does not require any additional structural supports. The floor of this addition is made of conventional solid wooden joists and plywood decking. The original design called for a conventionally framed

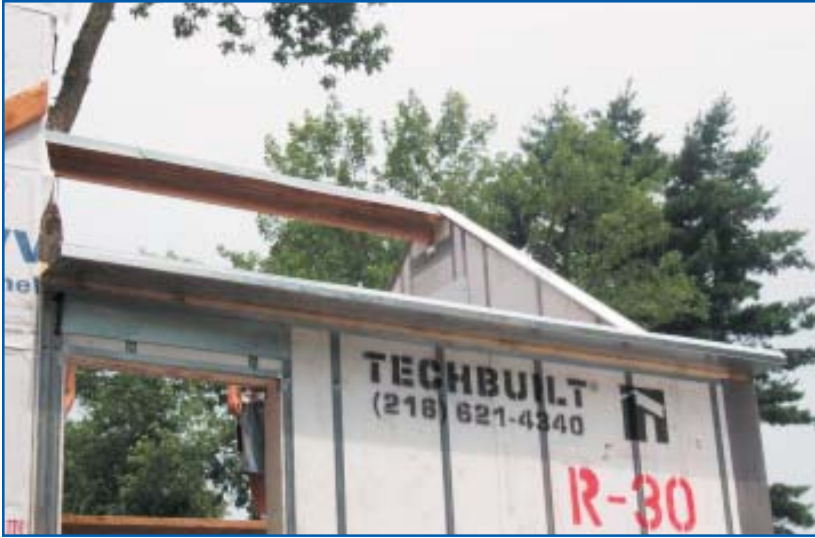
Ridge and eave supports for roof panels

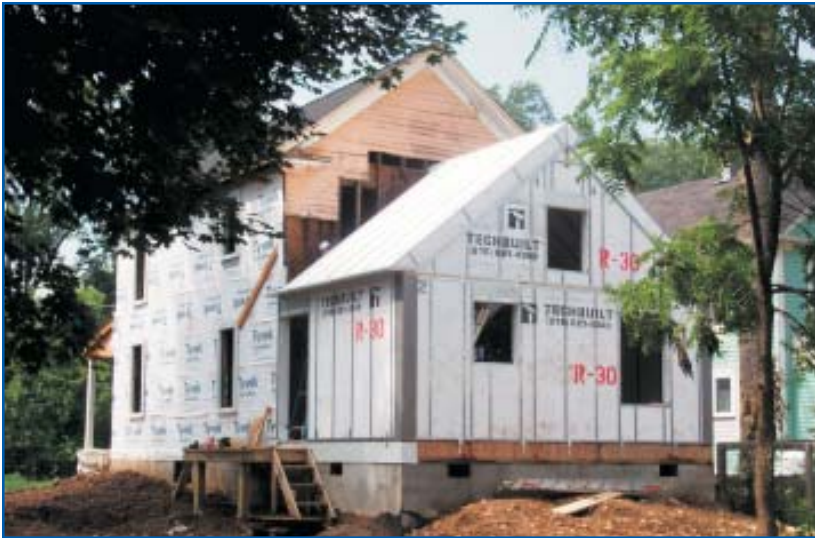
Addition constructed in 6 hours

addition with a vented attic. The choice to use structural panels allowed for the creation of a cathedral ceiling in the room and dramatically decreased the close-in time for the project. Once the conventional wooden deck had been built, it took the remodeler's crew of three, plus two support technicians from the panel manufacturer

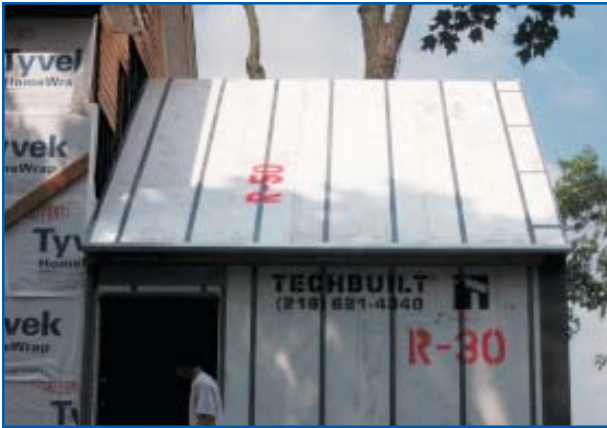
R-50 roof and R-30 wall panels

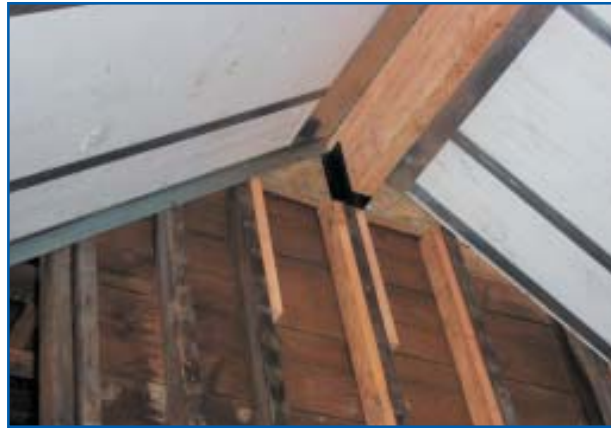
Ridge beam for roof support

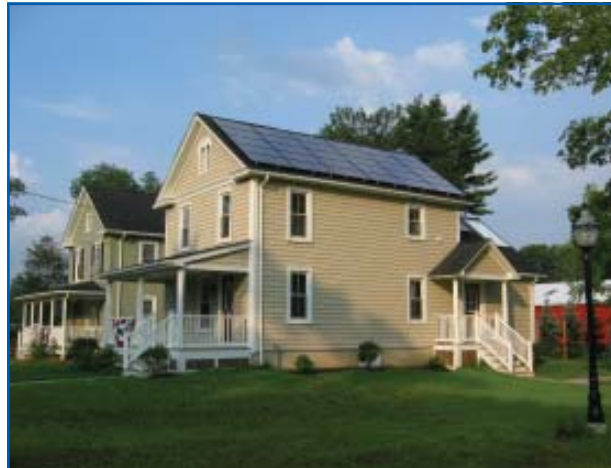
PV system on cottage home

A 3.0 kW mono-crystalline system is located directly on the Cottage roof with a 4.2 kW system located on the garage roof also feeding into the building’s utility service.

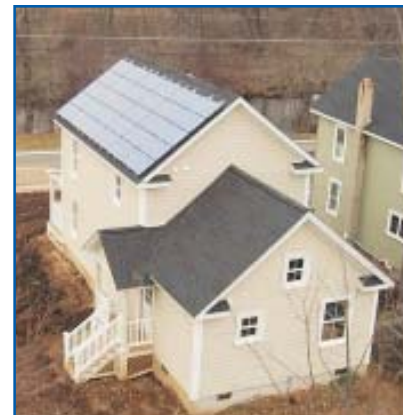
Aerial view of PV system

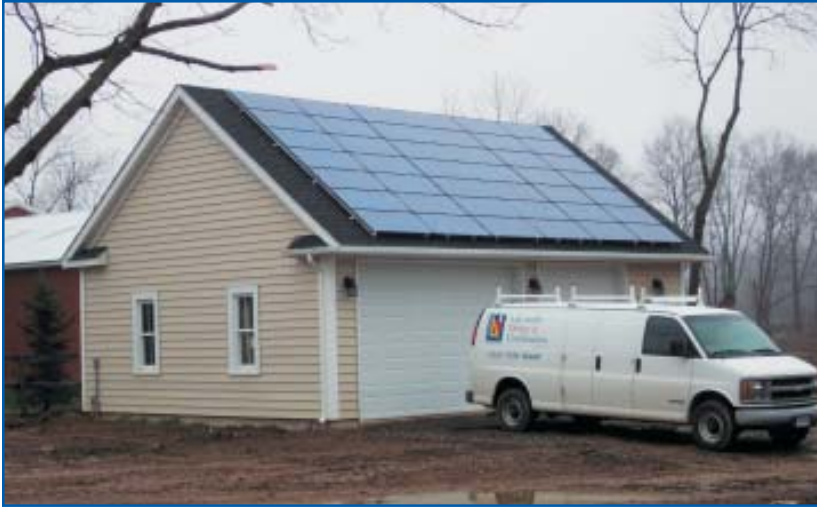
Garage PV system for cottage home

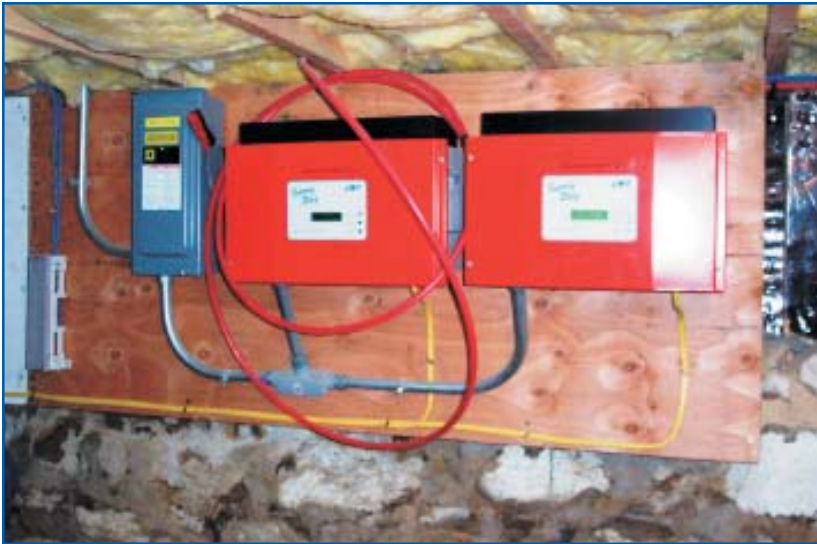
PV system inverters

The power conditioning inverters are located inside both in the garage and basement of the home. The out of pocket expenses for the homeowner are approximately \$15,120. The NJCEP rebate paid for 70% of the system or \$35,280. The system is expected to produce approximately 9,000 kWh per year.
